Case Studies in Construction Materials

Corrosion assessment of reinforced concrete elements of Torre Velasca in Milan

Federica Lollini*, Elena Redaelli, Luca Bertolini

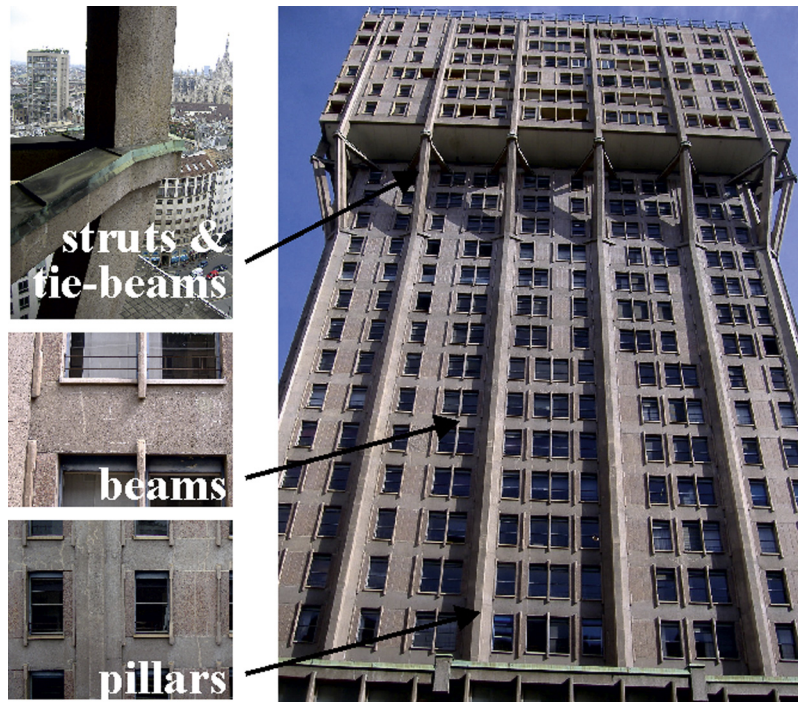
Torre Velasca was designed by the B.B.P.R. studio and built in 1956–1958 [4]. The tower, which is 106 m high and has 29 floors (Fig. 1), two of which are underground, can be divided in three zones: the lower part, from the ground level to the 15th floor, the intermediate part from the 16th to 18th floor, and the upper part till the 26th floor. The dimensions of the lower and intermediate zones are $21.08\text{ m} \times 38.46\text{ m}$; struts and tie-beams, which are present in the intermediate part, support the larger upper part, which is $27.40\text{ m} \times 44.78\text{ m}$. The perimeter of the tower is characterised by the presence of projecting load-bearing pillars, beams, struts and T-beams (Fig. 1). According to available documents, major repair works had been carried out on the facades in 1978–1979 and in 1995, due to evident deterioration of structural elements.

Fig. 1. View of a facade of Torre Velasca and indication of structural elements.
